# **MPGD Photon Detector Upgrade for COMPASS RICH**

**Gergő Hamar**

**for the THGEM group of INFN Trieste**  
S. Dalla Torre, F. Tessarotto, S. Levorato,  
S. S. Dasgupta, G. Hamar, C. Azevedo

**Instrumentation for Colliding Beam Physics**  
**Budker INP, Novosibirsk, 2017**

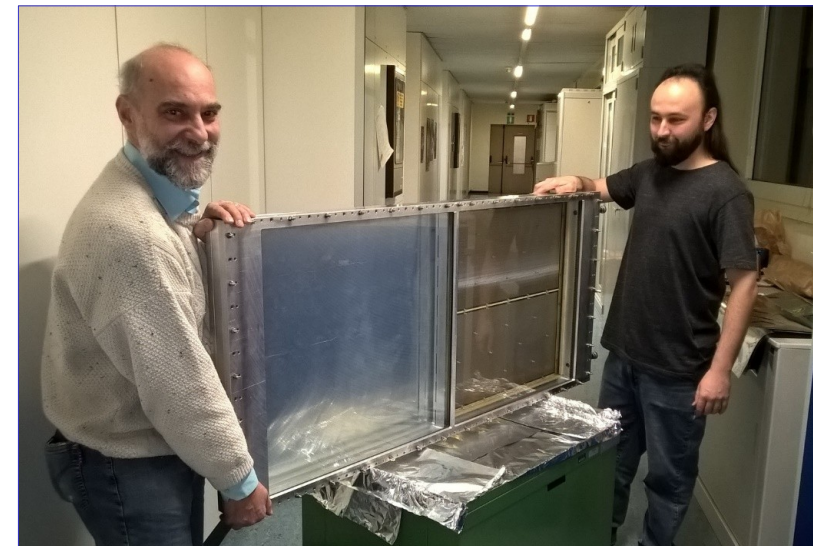
- **Double ThickGEM + Bulk Micromegas**

**Photo conversion** : first THGEM coated with CsI

**High gain** for single photo-electron detection

**Low Ion BackFlow** : MM + staggered THGEMs => ~ 2%

Producer: ELTOS Italy ; Size: 600x300 mm<sup>2</sup>

Parameters: thickness:400μm, pitch:800μm, hole:400μm, rim:10μm,

**Capacitive readout**, discrete resistors 500MΩ, Mesh on ground

Producer: PCB at TVR, bulk MM at CERN; Size: 600x300 mm<sup>2</sup>

- Padplane: 8x8 mm<sup>2</sup> padsize

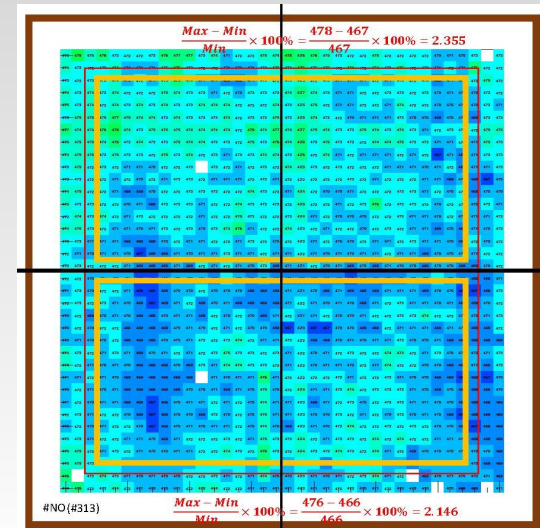
$\delta_{TH}$  Distribution PCBs

- ThickGEMs
  - Material selection → uniform thickness
  - Polishing → smooth copper edges
  - Paschen test in N<sub>2</sub>
  - Discharge test in Ar-CO<sub>2</sub>
  - Gain and uniformity measurements with X-rays
  - Test after gold plating
  - CsI coating's QE measurement
- Micromegas
  - Electrical check of HV pads
  - Gain and uniformity measurements with Fe-55

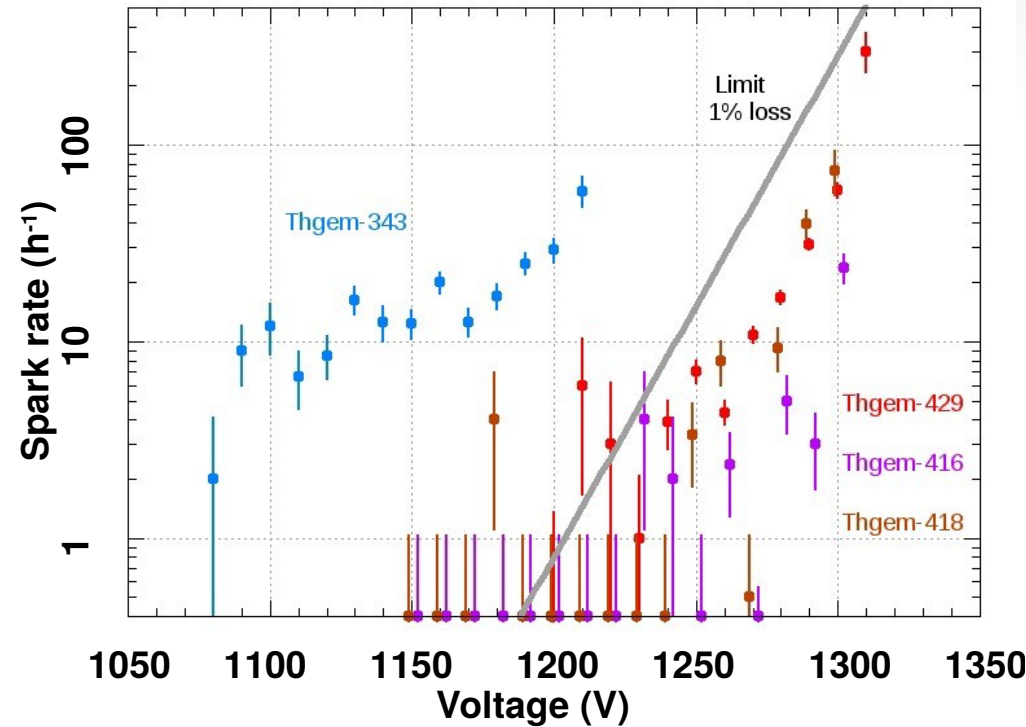
- ThickGEMs
  - Material selection → uniform thickness
  - Polishing → smooth copper edges
  - **Paschen test in N<sub>2</sub>**
  - **Discharge test in Ar-CO<sub>2</sub>**

Cleaning with X-rays

Reproducibility & Cleaning sparks in Paschen test

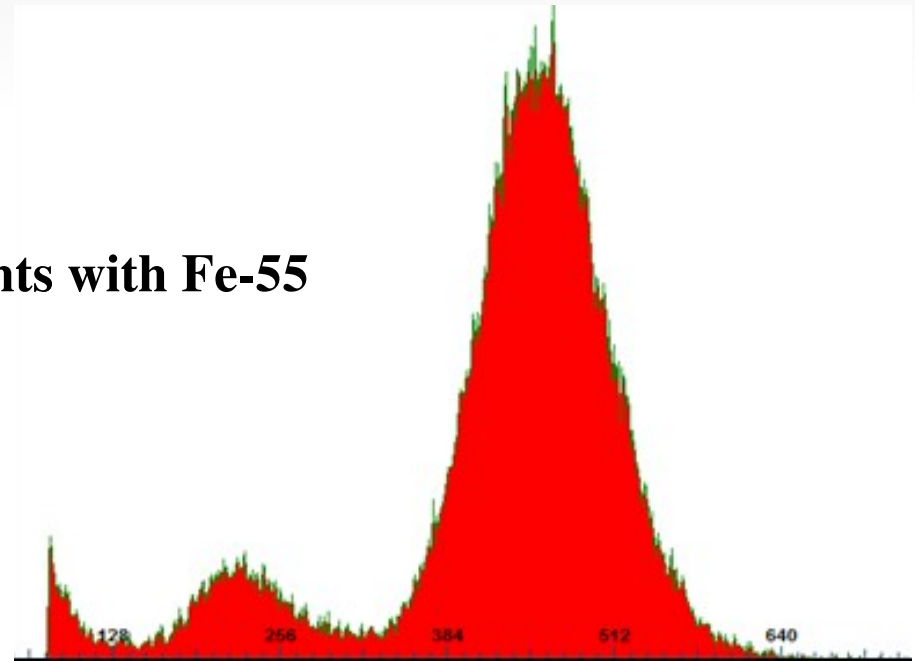
- ThickGEMs
  - Material selection → uniform thickness
  - Polishing → smooth copper edges
  - Paschen test in N<sub>2</sub>
  - Discharge test in Ar-CO<sub>2</sub>
  - **Gain and uniformity measurements with X-rays**
  - Test after gold plating
  - CsI coating's QE measurement
- Micromegas
  - Electrical check of HV pads
  - **Gain and uniformity measurements with Fe-55**

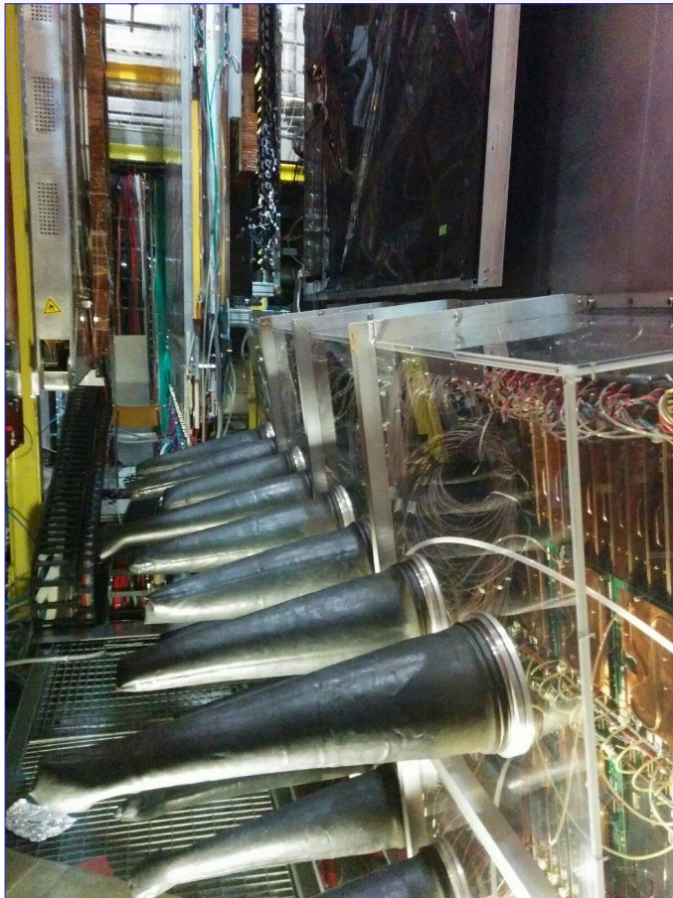
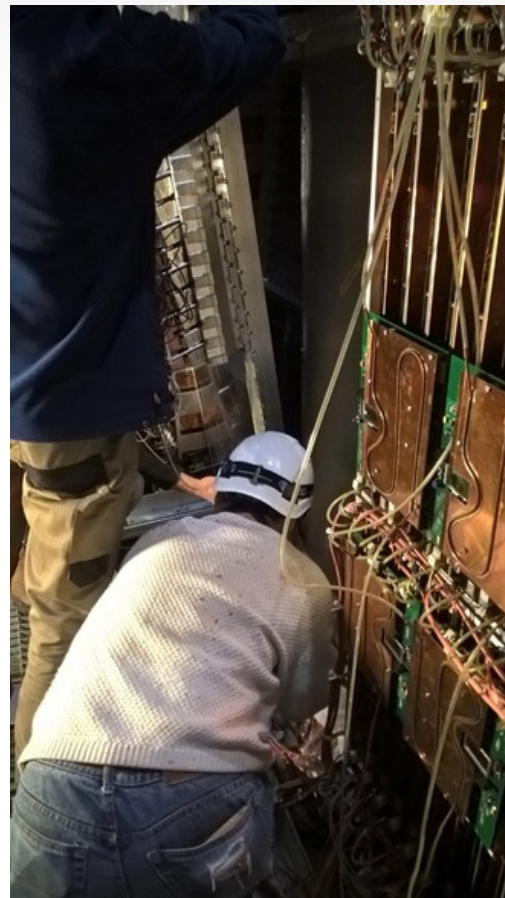
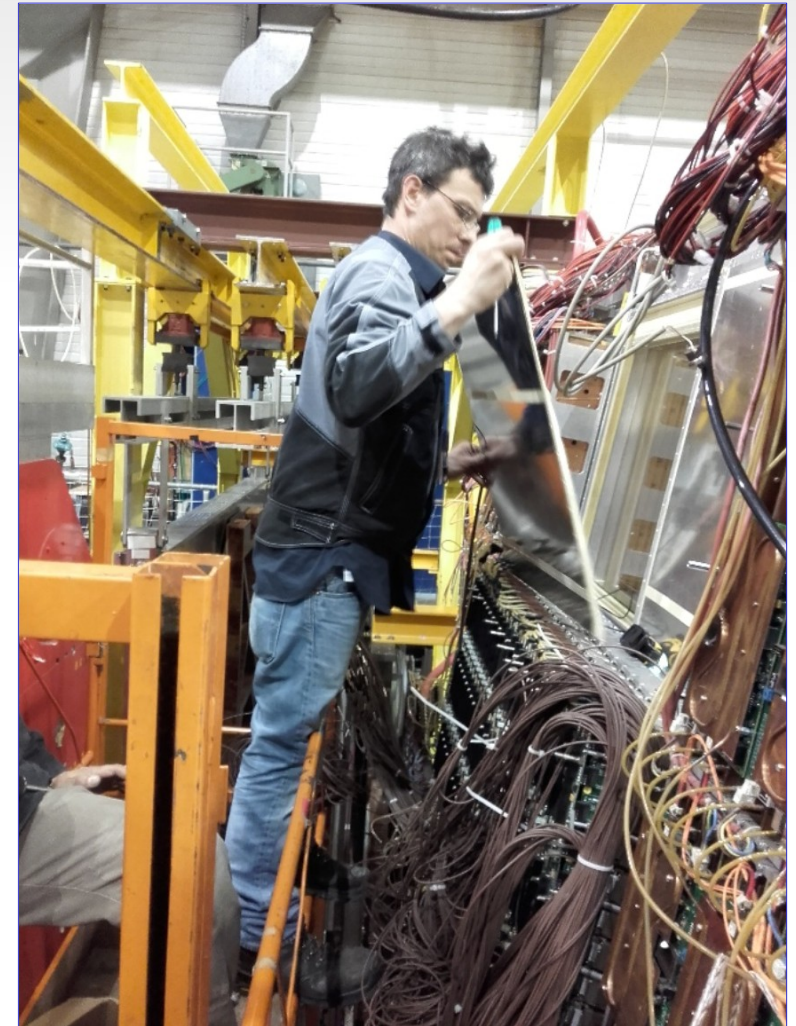
- MAPMT part remounted
- Hybrids: due to the CsI  $\rightarrow$  mounting is a **glove box** operation
- + High Voltage (new sytem)
- + Electronics (used system)
- + Cooling (upgraded)

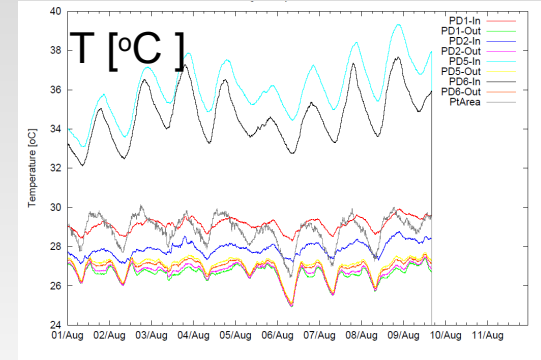
- **Custom made HV system** (C++, wxWidgets)
- Coop. with **COMPASS DCS**
- **Correction wtr P/T** in amplifier regions
- "OwnScale" to finetune for **uniformity**
- **Log** with 1 Hz
- **Spark detection**
- Autodecrease HV if too many sparks
- Interaction via: GUI, DCS, DIM, Msg
- Gain variation in lab 40% → 10%
- Needs to be verified on the CompassData
- HV Units from CAEN  
 SY2745 (x2): HvCrate  
 A7030 (x2): +3kVx12ch  
 A1561 (x8): -6kVx12ch

**P/T: ~1% →**  
**Gain: ~40%** <sup>20</sup>

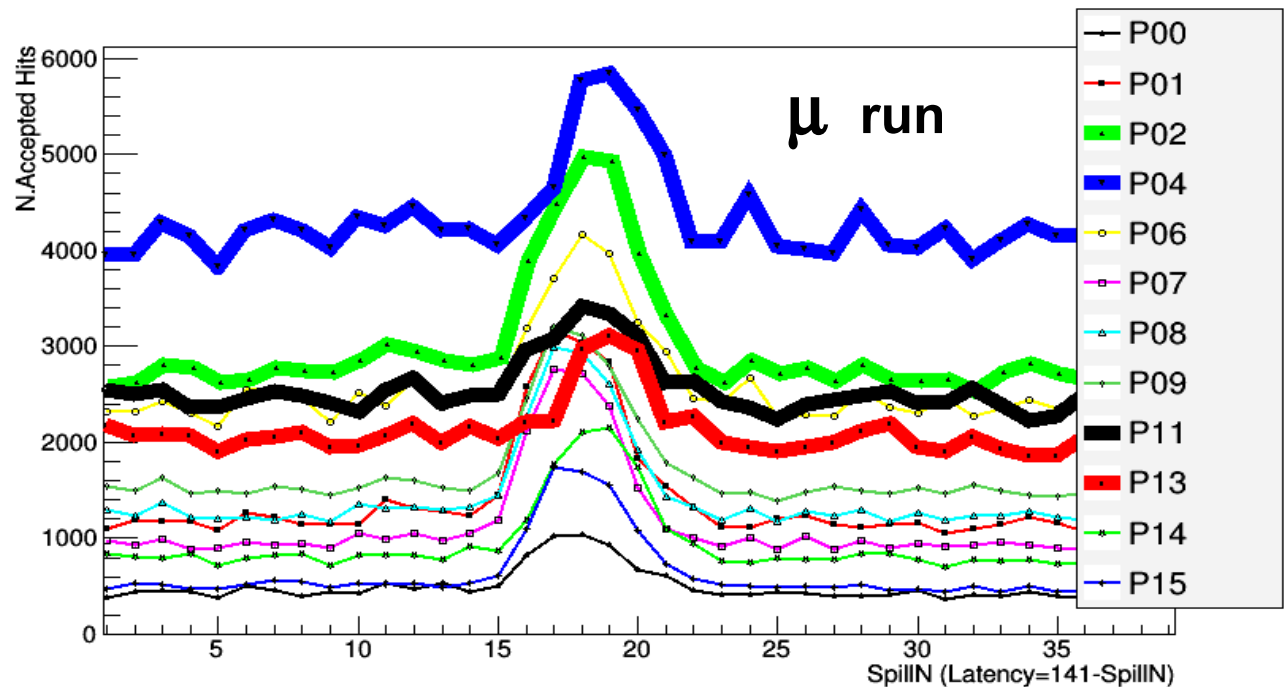
- RICH FEE : **APV25** + DAQ chain
  - integration, shaping, sampling, pedestal subt., zero sup., send data
- Latency settings depends on trigger system and signal formation
- **Latency scan** with several configurations (HV and beam) [ LatencyUnit=25ns ]
- Amplitude measurement in 3 samples, separated by 150ns  
Baseline (A0), Rising edge (A1), Maximum (A2) [ AdcUnit=300e ]
- **Signal shape** is visible, short plateau at maximum, fast rise defines narrow timing
- **Clear indication on the presence of the signal !**

$$\begin{aligned} 0 &\leq A0 < 5 \\ 20 &< A2 < 500 \\ 0.2 &< \frac{A1}{A2} < 0.8 \end{aligned}$$

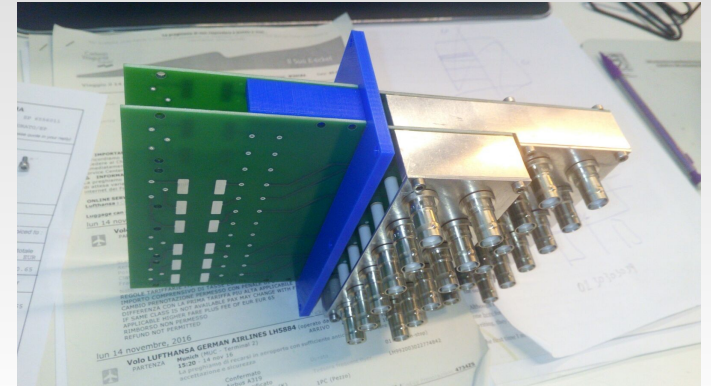
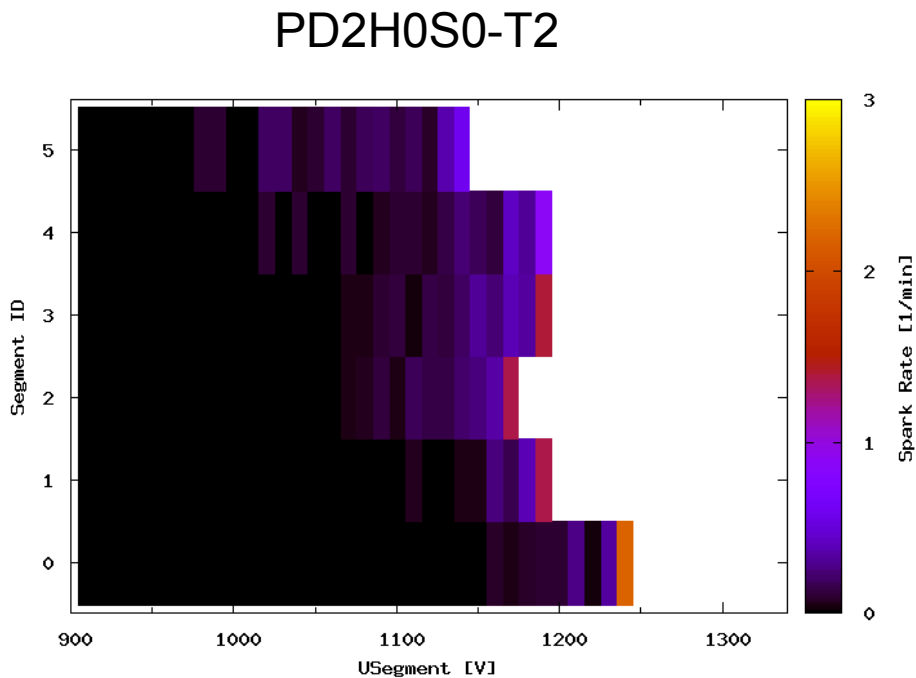
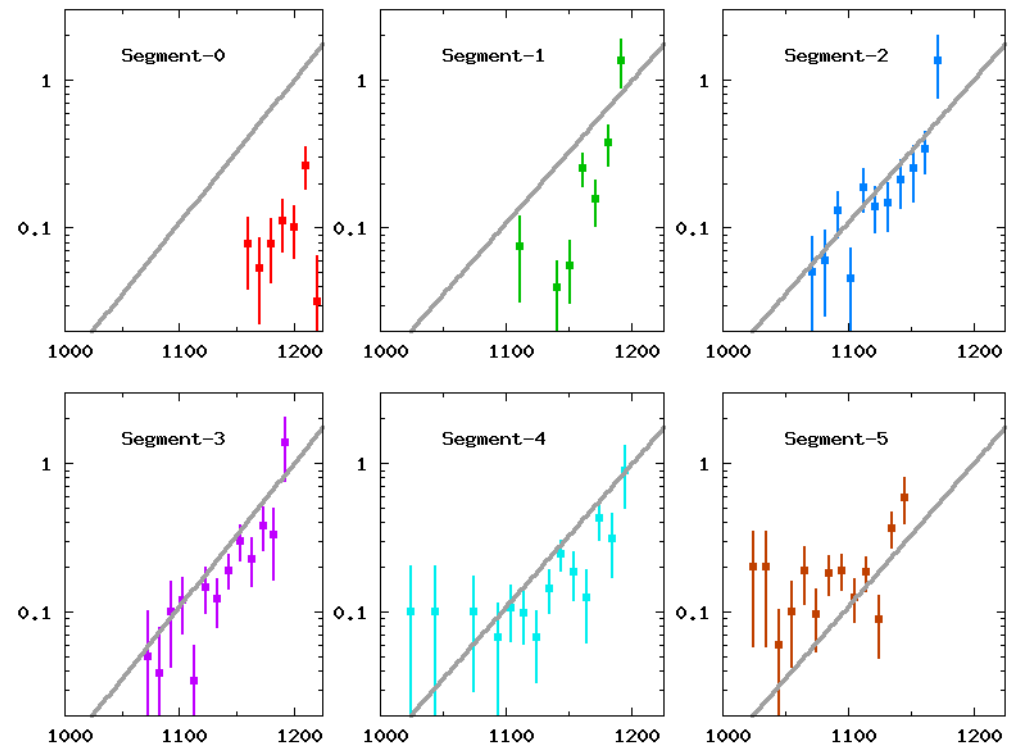
- The feeble Sectors will be investigated  
**Spark rate measurement at Segment level**  
(24mm wide strips means 4% of a detector)
- **Weak segments** can be **identified**  
and later if needed eliminated
- Testing has been started, and foreseen  
to continue during the next weeks
